Failure of an autotank repaired by welding

Fallas de soldadura de reparación de autotanke

Citation: SALGADO-LOPEZ, Juan Manuel, OJEDA-ELIZARRARÁS, José Luis, SILVA-HERNANDEZ, Abraham and TELLO RICO, Jesús Mauricio. Failure of an autotank repaired by welding. Journal of Scientific and Technical Applications. 2020. 6-17:1-9.

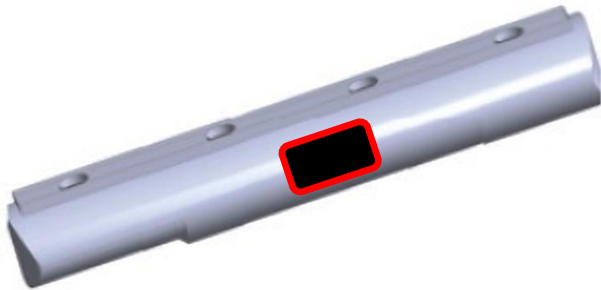
Figure 1 The image shows the failed section of the vessel
Source: own work [PDFcreator]

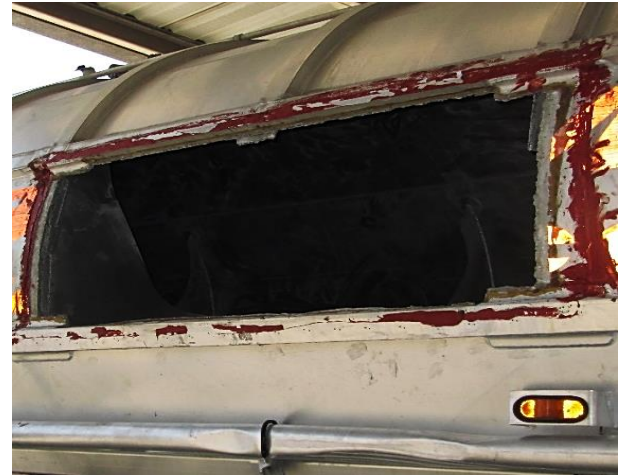
Figure 2 The image shows the original fracture of the vessel and the fracture of the weld joining the patch. Evidence of the polymer placed on the edge of the patch plate (red spot) was found
Source: own work [Canon powershot A3400IS]

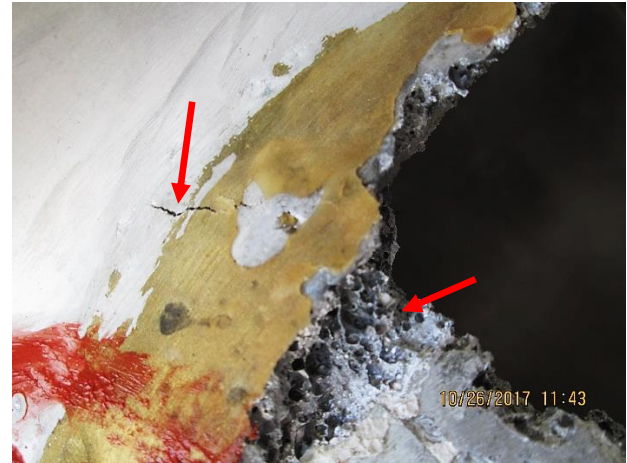
On the other hand, it should be noted that evidence of resin was found on the welded joints of the vessel. In addition, this evidence of resin was observed throughout the outer and inner surfaces of the weld metal.

Figure 3 The image shows the fracture surface of the repair welding, there is evidence of polymer and porosity
Source: own work [Canon powershot A3400IS]

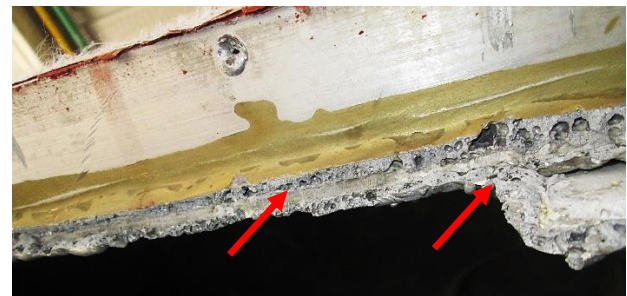
Figure 4 The image shows more evidence of the polymer on the weld metal and porosity on the crack
Source: own work [Canon powershot A3400IS]

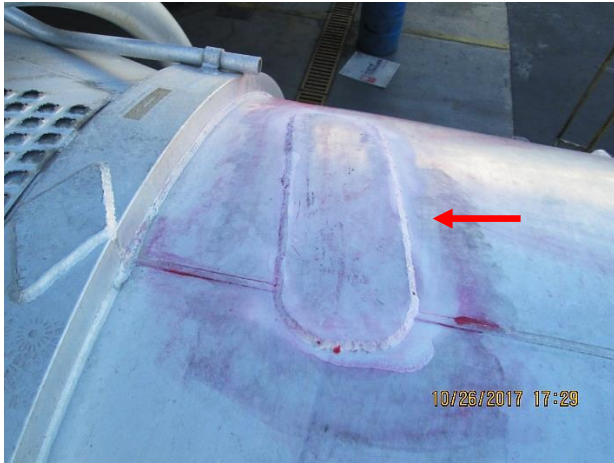
The visual test in the vessel showed evidence of repairs away the failed patch. The Dye penetrant test that carried out on the external surface of the welding of the vessel indicated that there were flaws such as undercuts (figure 5 and 6) but there was no evidence of crack growth of the defects located on the weld metals of such repairs. This evidence meant that this vessel did not suffer from any excessive pressure. This fact matched with the Dye penetrant test performed on the surface patch in the upper part of the vessel, where no evidence of overpressure damage was found [19].

Figure 5 The image shows the results of the inspection by penetrating liquids in a previous repair by welding of the failed vessel. No indications are observed
Source: own work [Canon powershot A3400IS]

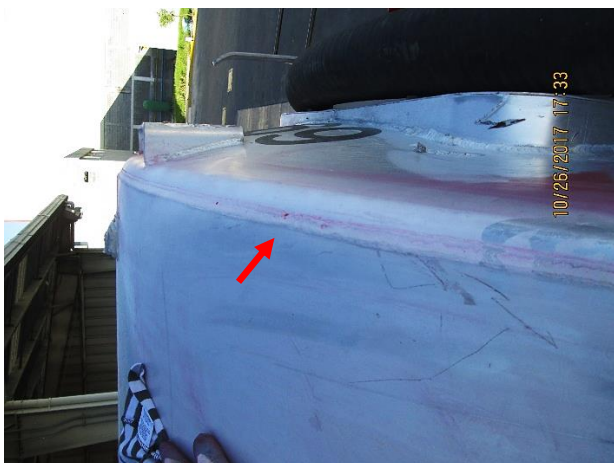
Figure 6 The image shows the results of the inspection by penetrating liquids in a previous repair by welding of the failed hopper. No indications were observed
Source: own work [Canon powershot A3400IS]

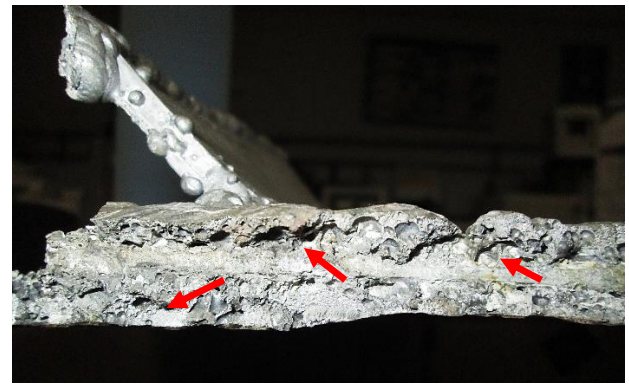
Visual testing in the laboratory using a stereographic microscope confirmed the existence of defects such as porosity, lack of fusion and incomplete penetrations along the weld seams present in the patch plate of the vessel under analysis (figures 7 and 8). This also applies to welded joints of the internal reinforcements of the patch plate. This evidence is very important because it indicated that the welding process of both welds were performed in not the best way [19].

Figure 7 The image shows the fracture surface. Porosity is observed as well as fracture grew along the weld seam
Source: own work [Canon powershot A3400IS]

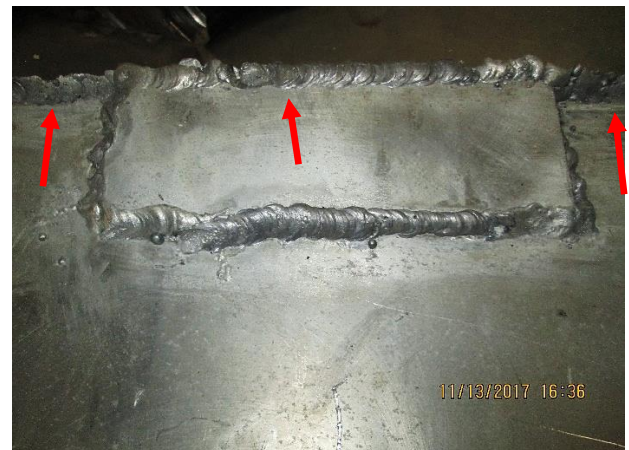
Figure 8 The image shows 7X that the fracture grew along the weld seam
Source: own work [Canon powershot A3400IS]

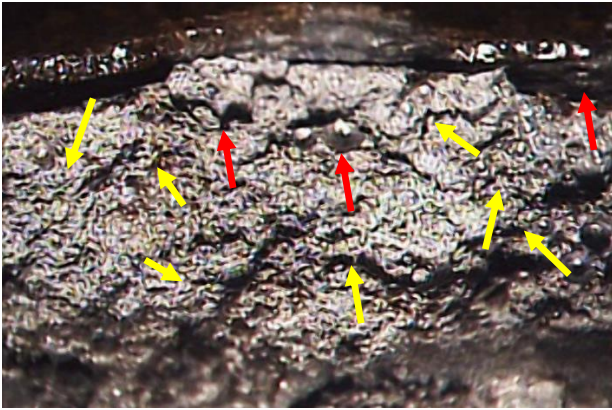
Another very important evidence was revealed by the inspection using a stereographic microscope. This evidence was fatigue marks in many regions of the weld bead (Figure 9). This fact is important because it confirmed that in the failure of this welded joint occurred by fatigue but several regions with origins of fatigue marks indicated the existence of multiple origins of the fracture. In this way, it was remarkable that all fatigue origins were located in welding defects such as incomplete fusion or aligned porosity [6-7]. These facts were confirmed by the inspection using SEM.

Figure 9 The image shows the fracture surface at 10X. Porosity and fatigue marks (yellow arrows) are observed. There is seen three cracks origin (red arrows)
Source: own work [Leica stereoscope]

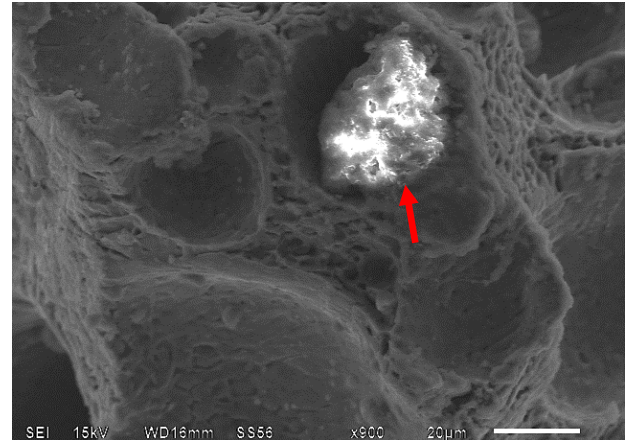
Through the inspection by Scanning Electron Microscopy (SEM) on the fracture surfaces of the fractured specimens the existence of fatigue striations was demonstrated. This fracture pattern proved that the cracks grew due to the fatigue mechanism (Figure 10). However, there was not a single crack origin but several, so it was not possible to determine the origin of the primary crack. This evidence matched with the information about the four year work of this vessel after the repair of the vessel with a patch plate. This working time is reflected in the number of fatigue cycles and the fact that weld metal failed in the last loading event indicated that the final fracture was caused by the classic plastic collapse in fatigue failures.

In this same sense, in the fracture surfaces evidence of polymer was found in the porosity detected (figures 10 and 11), this fact indicated that the fracture surface was in contact with the polymer powders before the final failure of the patch plate occurred. If one takes into account that the polymer was only housed inside the vessel then it is feasible that the crack grew for four years and the weld collapsed in the last material loading event [20-23].

Figure 10 The SEM image shows striations due to fatigue and evidence of trapped inclusions
Source: own work [JEOL JSM 6610L]

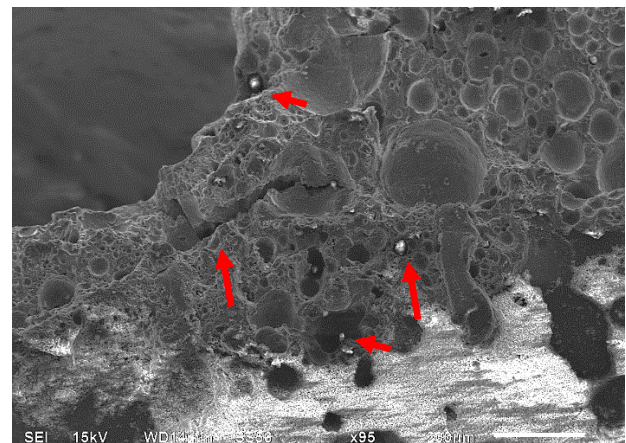
Figure 11 The SEM image shows evidence of organic matter trapped between the fracture dimples
Source: own work [JEOL JSM 6610LV]

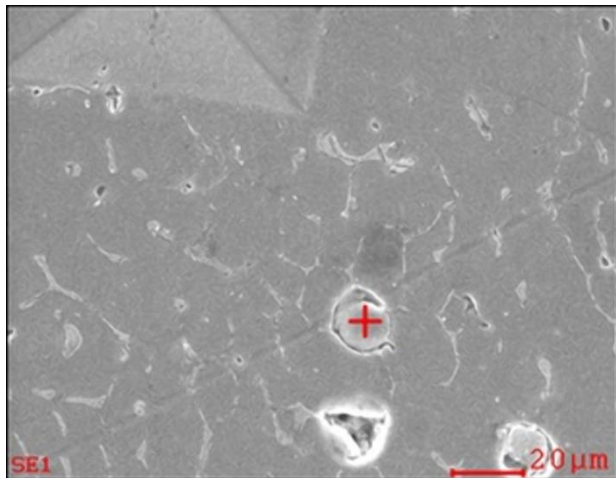
In the case of the Energy Dispersive X-ray Spectroscopy microanalysis (EDS) performed in cross-section sample of the weld metal prepared for metallography. There was found evidence of a trapped inclusions (figure 12), the EDS results indicated that it was aluminum oxide (figure 13), whereby this trapped alumina originated in the preparation of the welded joint. In the literature it has been reported that the most common causes of porosity in aluminum welding are: contamination on the surface to be welded, the poor preparation of the parts to be joined, the inadequate application of protective gas, applying welding dragging to the weld metal, to use a carbon steel bristle brush to clean the surfaces to be welded [3, 6].

Figure 12 The SEM image shows a trapped particle in the microstructure of the weld metal where EDS microanalysis was carried out

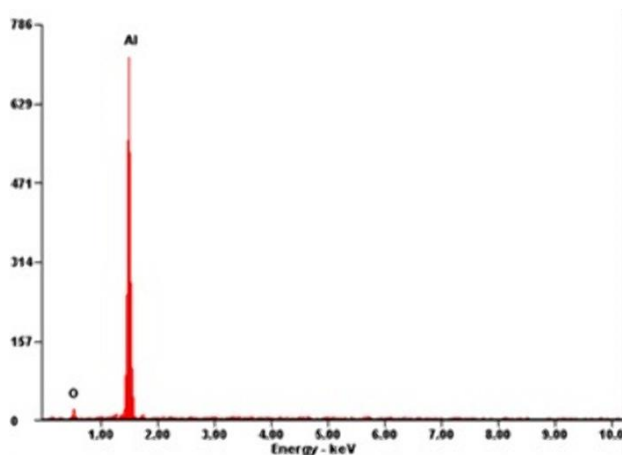
Figure 13 The image shows the results of the EDS microanalysis performed on one of the inclusions trapped in the weld bead

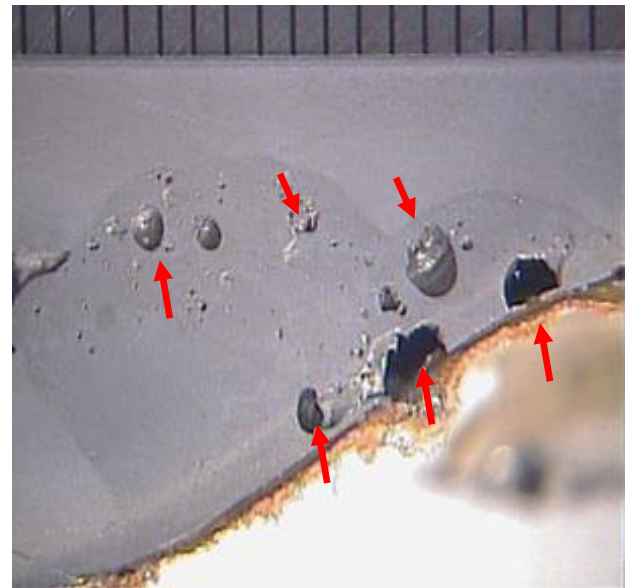
The macrostructural analysis performed on the welded joint probed the existence of welding defects and non-efficient joint design (figure 14). Similarly, it is clear that aligned porosity located on the surface of the weld metal was covered by a polymer layer (Figure 14).

These evidences indicated that the polymer coating (resin) should have been applied as a measure to prevent fluid leakage from inside the vessel, with which the weld inspection accepted the welding.

Figure 14 The image shows a cross section of the welded joint failed

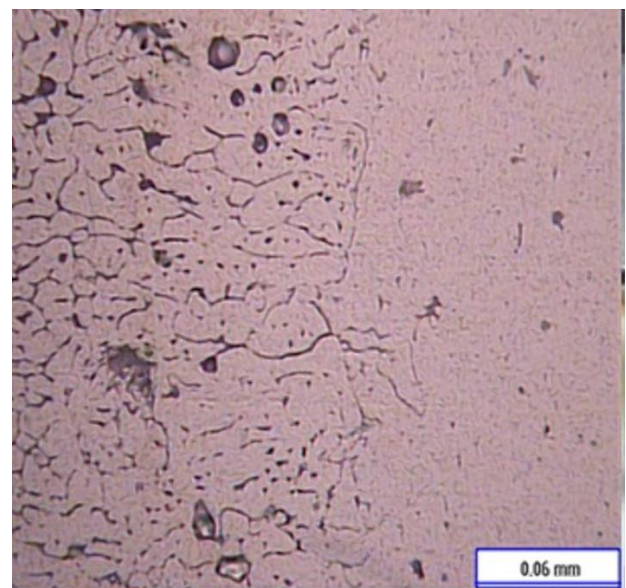
On the other hand, microstructural analysis showed the existence of dendrites and interdendritic precipitates, in addition to porosity of different dimensions in the microstructure of the weld metal (figure 15).

In the case of the microstructure of the Heat Affected Zone (HAZ), it is seen the existence of metallic precipitates of different types both in the grain boundaries and inside the grains. In fact it can be observed growth precipitates. This type of microstructure is consistent with the welding microstructures of precipitation hardenable aluminum alloys that have been welded (Figure 15).

Figure 15 The micrograph shows 500X the microstructure of the ZAT. Dendrites are observed more precipitous interdendritic and porosity
