Causes of cracking in the turbine housings of a turbocharger

In this chapter, the procedure to determine the failure cause of the cracking of a casing that was exposed during its operation to thermal shock and fatigue conditions is explained. The areas of materials science and mechanical engineering are fundamental to determine the necessary studies according to the conditions and variables to be studied for this type of problem. The fundamental cause of cracking in the casing is due to thermal shock and fatigue which promote cracking. The maximum stress amplitude encountered due to thermal shock exceeds the permissible design limits. This work has been carried out in collaboration with the Centro de Investigaciones de Soldadura (CIS), Facultad de Ingeniería Mecánica e Industrial. Universidad Central "Marta Abreu" de Las Villas, Santa Clara, Villa Clara, Cuba. The Technological University of Campeche, San Antonio, Cardenas, Ciudad Del Carmen, Campeche and the Autonomous University of Carmen, Cd del Carmen, Campeche, Mex.

Temperature variation in turbocharger casings of generator sets generates shocks and thermal fatigue that cause cracks in different areas, with permissible limit

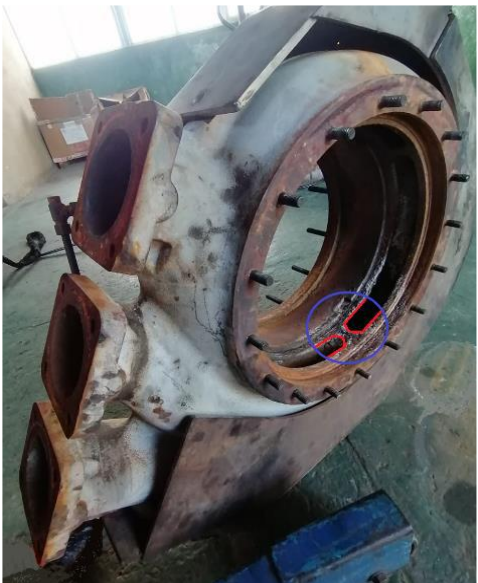
Box 1

The turbine is where the expansion of the gases coming from the engine cylinders takes place. The inlet of these gases is made through an orifice whose layout optimises the incidence of the flow on the blades, with this and the help of the snail-shaped housing (figure 1) the gases are distributed along the turbine losing pressure to make the shaft rotate. ([Rodríguez, L.A.M. 2019](#)).

Figure 1
Turbine casing belonging to a turbocharger of the Generator Sets

The casing is made of nodular cast iron, according to the ASTM A536 standard, which establishes 5 grades according to its mechanical properties; this standard is in correspondence with the GOST3443-87 standard.

The material under study corresponds to a segment of a casing (see figure 1).

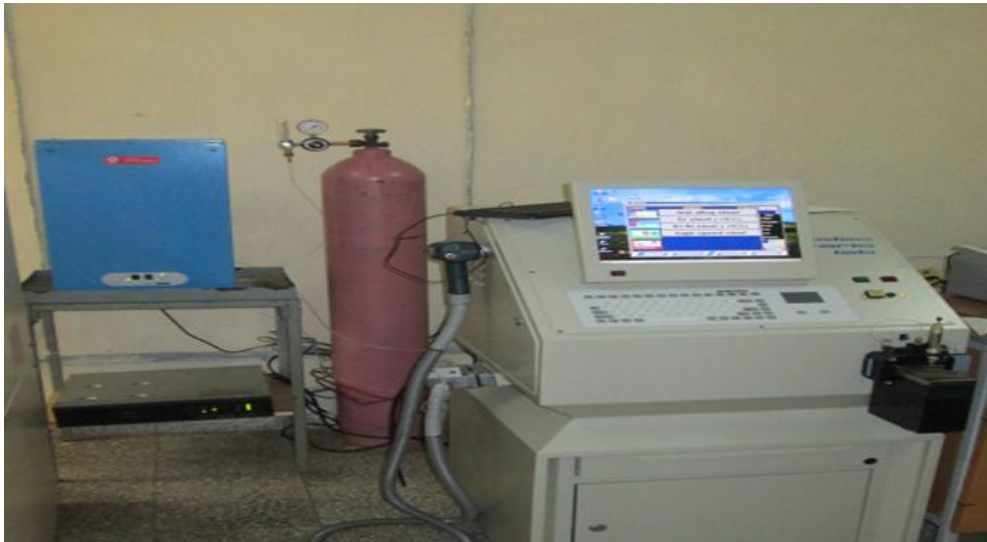
Box 2

The chemical composition of the samples extracted from the casing was obtained by the method of Spectral Analysis of Optical Emission, which was carried out in the Chemical Analysis Laboratory of the Planta Mecánica Company, Cuba, with the use of an Optical Emission Spectral Analysis equipment, Belec Vario Lab Spectrograph (Figure 2), which processes the data with the Belec Win 21 software, the equipment's own. Prior to the analysis, the equipment was calibrated with the foundry standards.

Figure 2
Optical emission spectral analysis equipment

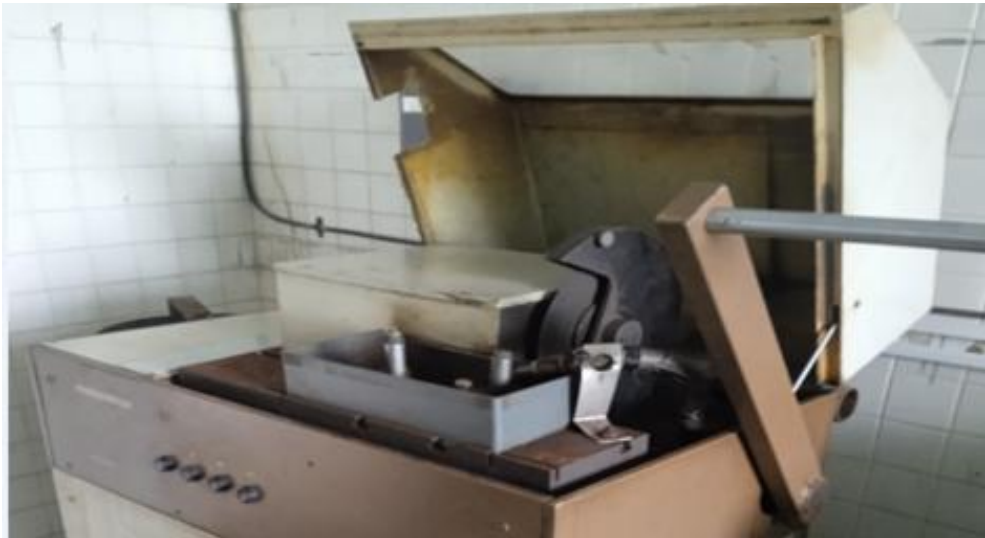
Box 3

To prepare the specimens for metallographic analysis, samples were taken from a section of the carcass, by means of cuts on a metallographic cutting machine (Figure 3) in the Heat Treatment Laboratory of the Welding Research Centre.

Figure 3
Metal cutting machine with abrasive disc

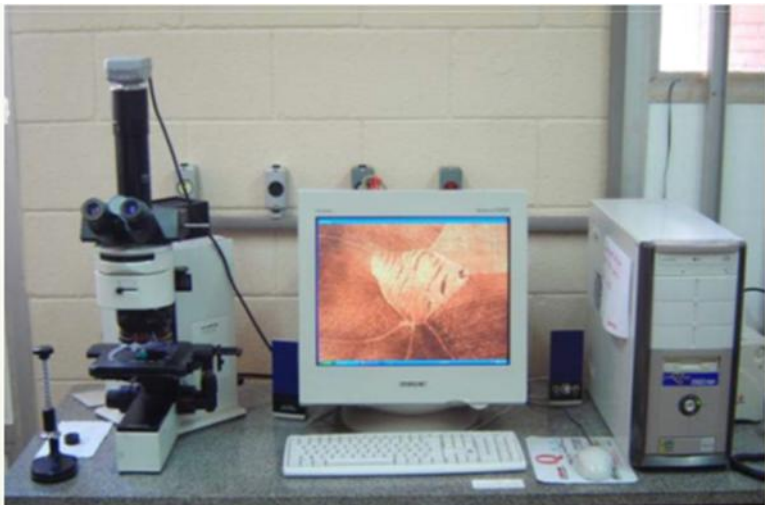
Box 4

The metallographic observation of the samples was carried out with the help of a Novel optical metallographic microscope at the Materials Science Laboratory of (CIS-MET-027, 2002). Images of the microstructure were taken with a high sensitivity 1.3 pixel Yuva camera attached to the eyepiece of the microscope and to a computer with specialised software (Image J) for image acquisition, as shown in Figure 4.

Figure 4
Optical metallographic microscope, image acquisition camera and computer

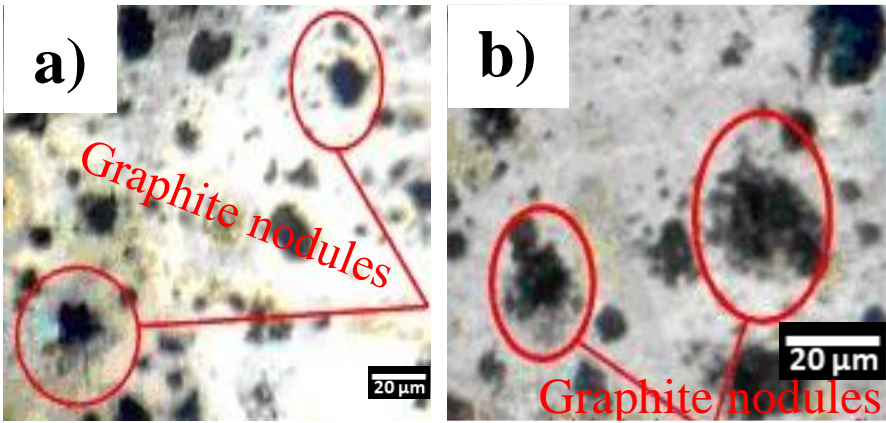
Box 8

The following figures 6a and 6b at different magnifications show the type of melt and the matrix to which this material corresponds.

Figure 6
Casing material microstructure (a- 200 X, b-400 X). CIS-MET-027
Source: Own elaboration

According to figure 6 it can be seen that the type of material present in the casing according to GOST 3443 - 87 is nodular cast iron (non-regular nodular inclusion shape), inclusion size 15-30 μm and uniform distribution of the ferritic matrix. This malleable cast iron, which is obtained by annealing (malleabelling) of white cast iron. In malleable cast iron, all or a large part of the carbon is in the free state in the form of nodules (carbonoderescent).

This compact, almost equiaxial shape of the graphite, but not round, is called nodular or annealed.

Through the microstructural and chemical composition characterisation it was determined that the casing material corresponds to a cast iron with inclusion of nodular graphite and ferritic matrix.

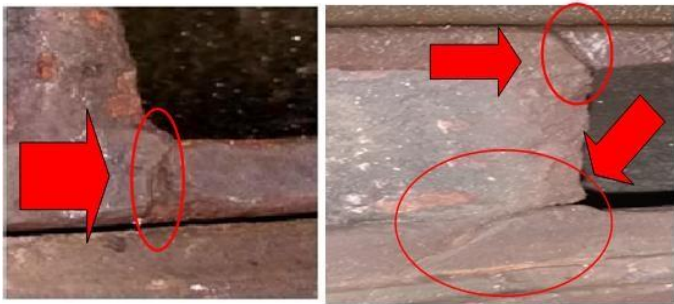
Box 9

Several casings were inspected out of operation due to cracking and it was observed that the cracks appear more frequently in the transversal direction, being these the most dangerous as they cause a rapid breakage of the turbo and leakage of exhaust gases, which gives the lowest permissible value of length, this is explained because in the transverse direction the stress concentration factor (kf) is much higher. The following figure (figure 7) shows the different cracks that have occurred.

Figure 7
Crack in the transverse direction

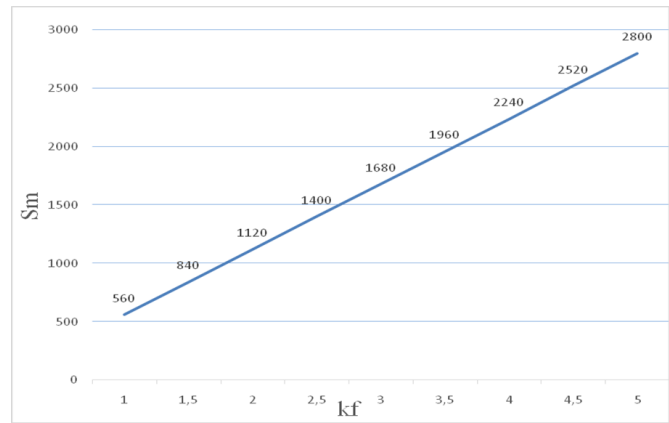
Box 10

The value of the maximum amplitude of the thermal stress generated during thermal shock (Sm) can be seen in the following graph (figure 8).

Figure 8
Maximum thermal stress amplitude generated during thermal shock as a function of stress concentration factor

The determination of the value of the maximum amplitude of the thermal stress generated during the thermal shock (S_m), is of great significance to have criteria about the appearance of cracks in the casing, if S_m is greater than S_a it implies that cracks will develop in the casing and due to the fact that the casing is subjected for intervals of time to this periodic stress, the cracks will propagate.

According to figure 5 for a stress concentrating factor (k_f) of the order of 1, the value that reaches the maximum amplitude of the thermal stress generated during the thermal shock (S_m), is greater than S_a , therefore, this justifies the appearance of cracks both transversely and longitudinally.

The maximum thermal stress amplitude generated during thermal shock (S_m), for the carcass under study, reaches a maximum value of 560 MPa for a stress concentration factor ($k_f=1$).

As the magnitude of S_m (560 MPa) is much larger than S_a (210 MPa) and the carcass is periodically stressed, this justifies the crack propagation.
