Evaluation of sinkholes in a civil work by capturing digital images using an unmanned aerial vehicle

This paper presents the results of a study carried out in a civil work located in a port of Ciudad del Carmen, Campeche, to detect the formation of sinkholes and quantify their dimensions using high-resolution aerial digital images acquired with an unmanned aerial vehicle at 60 m elevation and using 20 control points on site. Digital images were analyzed with ImageJ software to quantify and characterize the shape of the sinkholes in the civil work. Descriptive statistics were performed on the dimensions of the sinkhole structures identified, both in the field and in the digital images, to later compare the results obtained and evaluate the validity of the dimensions obtained from them. Likewise, a calculation of the percentage of damage in the perimeter was performed. The mean square and percentage errors were 0.03 m2 and 13%, respectively, which can be attributed to climatic factors during the acquisition of the images and the inherent limitations of the technique. 99 sinkholes were detected in the perimeter of the civil works, whose morphology and distribution suggest an origin r

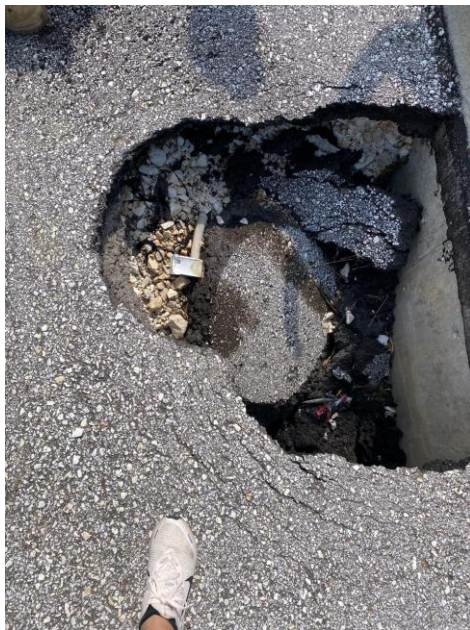
Figure 1

Formation of a sinkhole with collapsed asphalt layer in a port civil works, Ciudad del Carmen, Campeche

This paper analyses the formation of sinkholes in a civil engineering site in the port area of Ciudad del Carmen, Campeche (Figure 1), which represents a particular risk to infrastructure and economic activities in the region. Understanding the formation of sinkholes and their risks is crucial for urban planning and infrastructure safety.

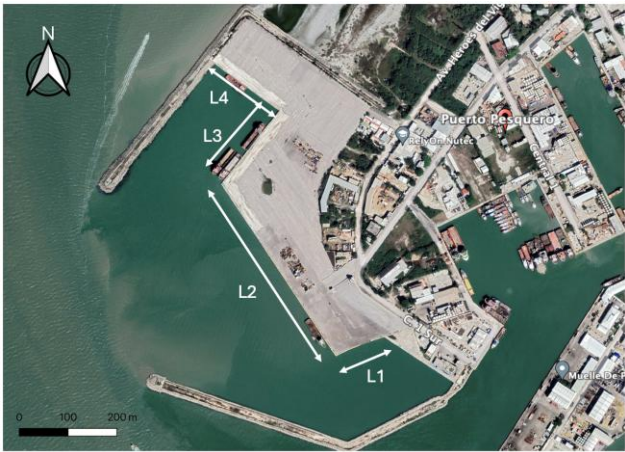
Figure 3
Location of the perimeter lines of the civil works.

Subsequently, descriptive statistics of the dimensions of the undercuts were developed and frequency histograms were elaborated. Similarly, the percentage of damage to the perimeter of the study site was estimated, considering the length of the major axis of the structures as the damaged perimeter, given that most of the undercuts are oriented with this axis parallel to the perimeter. In addition, the count of sinkholes per perimeter line (Figure 3) and the assignment of the orientation of the axis that is parallel to the perimeter was carried out, to finally determine the percentage of damage in each line of the perimeter in order to detect areas with greater damage.

The analysis of perimeter damage due to the formation of sinkholes indicates that 27.72% of the perimeter was affected. In addition, the analysis of the percentage of damage in each line of the perimeter shows that this is greater in line 1 and 2, with 48.87% and 37.62%, respectively, and with a greater average shaft size than the global average (Table 3).

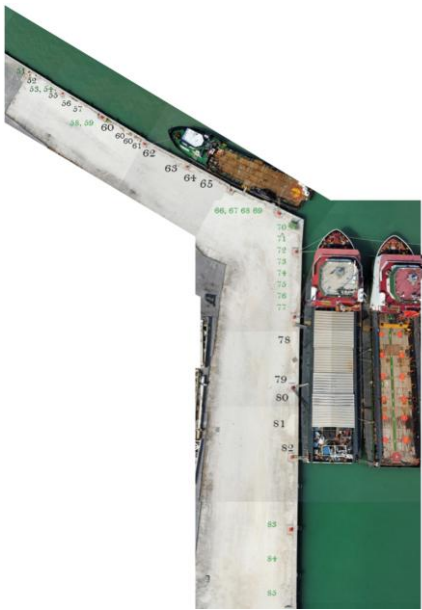
Figure 4
Location of the sinkholes on the perimeter of the dock under study

The analysis of the digital images identified 99 shallowly exposed sinkholes (Figure 4), whose dimensions for the major axis range from 0.23 to 10.50 m, with an average of 2.56 m and a standard deviation of 1.97 m, while the minor axis measurements show an average of 1.31 m and a standard deviation of 0.70 m (Table 1).

The causes of the formation of the sinkholes and the damage identified at the site can be associated with various natural and anthropic factors, such as coastal erosion, sea currents and vibrations produced by waves, maritime traffic, heavy machinery and other factors inherent to the structures. At the same time, it is important to point out that the damage to the perimeter of the dock may be aggravated by the high traffic of heavy vehicles and machinery that carry out loading and unloading manoeuvres, together with the vehicles that pass through on a daily basis due to the activities inherent to the port.

The results of the characterisation of the sinkholes, i.e. their size, shape, location, orientation and frequency of occurrence, suggest that the main control of their formation is related to the inadequate design of the civil works, particularly the perimeter retaining wall, and the damage is increased by the natural and anthropic factors to which it is exposed. In this regard, a study of sea currents is recommended in the design of this type of civil structures, in order to estimate the maximum stresses to which they will be subjected, as well as to consider future scenarios of rising sea levels and other effects associated with climate change, given that a rising sea level implies an increase in the magnitude of the stresses on the retaining walls. Similarly, a monitoring of environmental vibrations would provide relevant information for the rethinking of port manoeuvres and activities, in order to avoid further damage to the structure, giving a guideline to carry out the necessary actions to solve the problem of damage faced by the perimeter of the dock.

Finally, it should be noted that given the dimension of the problem at the site at the time of the study, the sinkholes were constantly filled with granular materials of different sizes and the most affected perimeter has been delimited to avoid overloading the civil structure.

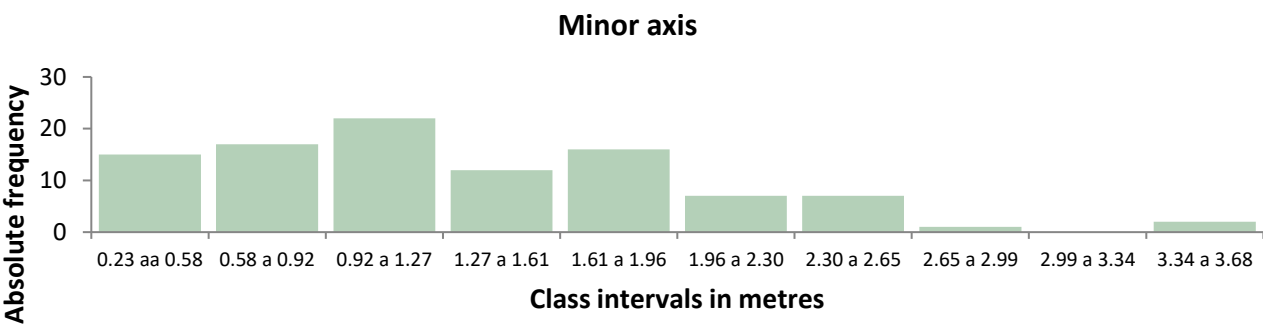
Figure 6
Histogram of absolute frequency of minor axis of sinkholes identified in the basin under study
Source [own elaboration]

Likewise, it is identified that the highest frequency of occurrence for the length of the major axis is found in the interval from 1.26 to 3.31 m, with 53% of the total number of sinkholes within this size (Figure 5), and for the length of the minor axis, the most frequent classes are found in the intervals between 0.23 and 1.96 m, grouping 83% of the total number of sinkholes in this range (Figure 6). The areas of the undercuts are in the range of 0.04 and 20.62 m2, with an average of 3.11 m2 and with a higher occurrence of those with areas smaller than 4.16 m2 (79%, Figure 7).
