## Factors influencing the welding process to generate the phenomenon of cut off fingers in photovoltaic modules

**Citation:** SALAZAR-PERALTA, Araceli, PICHARDO-SALAZAR, José Alfredo, PICHARDO-SALAZAR, Ulises and CHÁVEZ, Rosa Hilda. Factors influencing the welding process to generate the phenomenon of cut off fingers in photovoltaic modules. Journal of Technologies in Industrial Processes. 2021. 5-12: 9-16

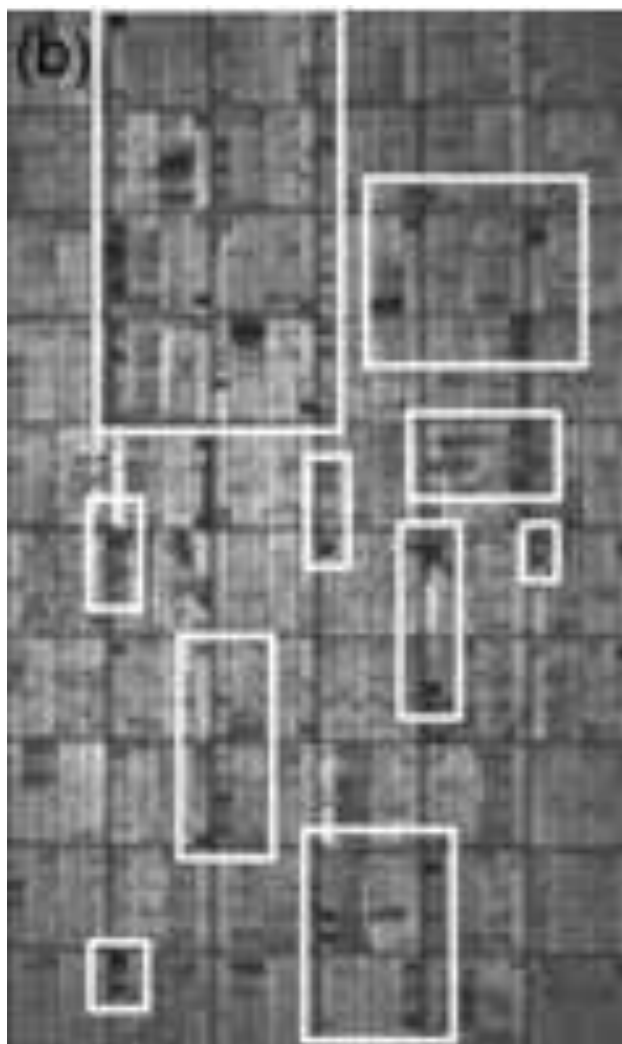
The deterioration affects the efficiency produced by the module through environmental factors, due to poor handling or maintenance, or due to defects caused during the production process, among which we can mention the defect of severed fingers that consists of the ruptures that present the collectors of the cell. Fig. 1.

**Figure 1** Cut Finger Collectors  
*Own Elaboration*

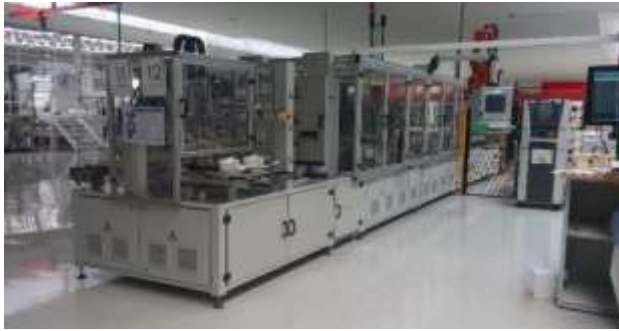
The stringer machine is an automated device in which the mechanism is a balance of temperatures of the solar cell by means of a preheating train to avoid a thermal shock in it when it comes into contact with a head with twelve pins. These pins make a type of spot welding because contact with the ribbon causes the heat to be distributed and joins with the cell buss. Figure 3.

**Figure 3** Stringer Brand Welding Machine  
*Own Elaboration*

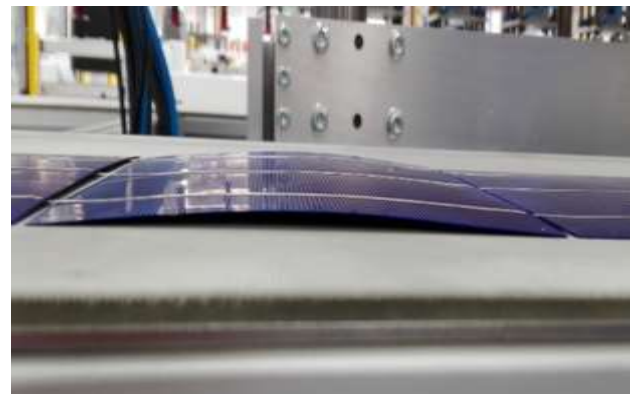
It is well known that a solid expands when heated, or contracts when cooled. The problem that causes a greater thickness of the ribbon, is that it increases the Coefficient of thermal expansion (CTE), causing the silicon wafer to become curved and at the same time cause the rupture of the fingers of the cell (Figure 4).

**Figure 4** Wafer affected by variation of thermal coefficient  
*Own Elaboration*

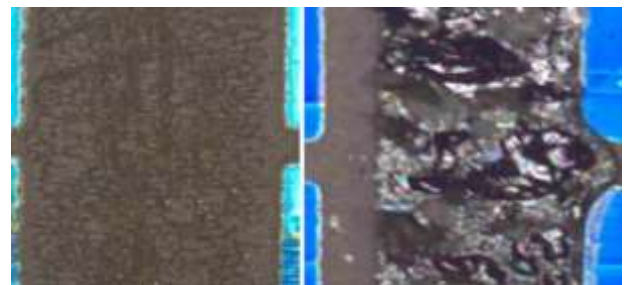
This is determined in the stress test (pull test) and with the help of a microscope when detaching the ribbon from the cell, a detachment of the buss can be observed, and the silicon plate can break. (Figure 5.).

**Figure 5** Penetration of Welding in the Buss of the Cell  
*Own Elaboration*

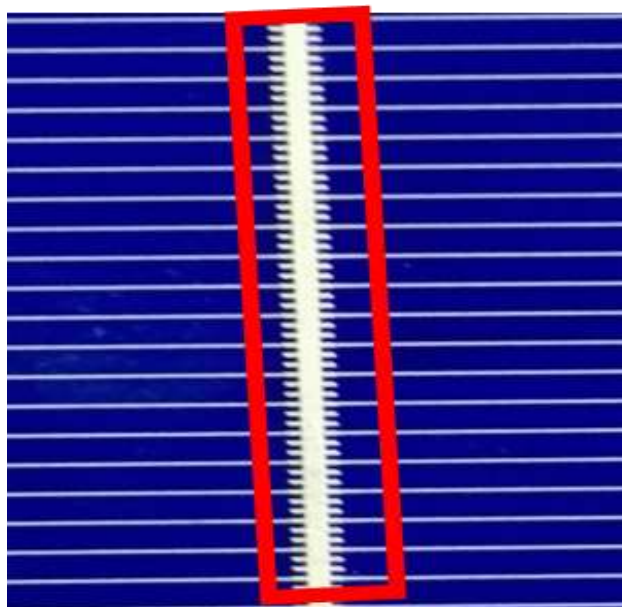
**2.4 Lack of welding.** Lack of welding is another defect caused by variations in temperature. Figure 6.

**Figure 6** Cell with missing solder  
*Own Elaboration*

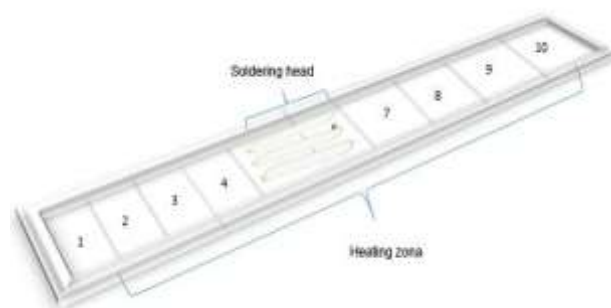
The train of the heating zones is divided into ten zones, where the first four are pre-arranged raising the temperature of the cell and the ribbon, in zones five and six are the points where the joining process (welding) occurs, and the remaining points are another conditioning, in which the temperature gradually decreases to avoid a thermal shock, figure 7 illustrates the 10 areas mentioned. The measurement was made with an infrared thermometer brand Fluke 566.

**Figure 7** Scheme of preheating zones (1, 2, 3, 4) and of welding (5, 6) of Stringer Machine  
*Own Elaboration*

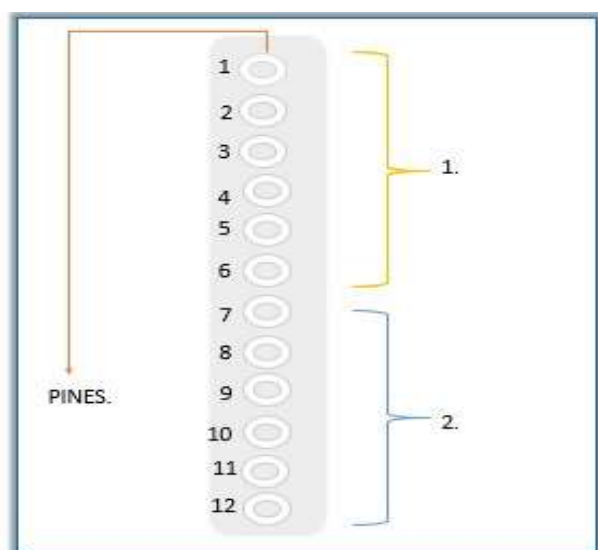
**3.3** The head has 12 pins, to make the temperature measurements, it was taken into consideration that each head has two resistors (zones 1, 2), which was taken into consideration for the reading shot. Figure 8, the zones (1, 2) are identified as soldering head in Figure 7. Tables 3, 4, 5 find the results of the measurement.

**Figure 8.** Stringer Welder Heads Diagram

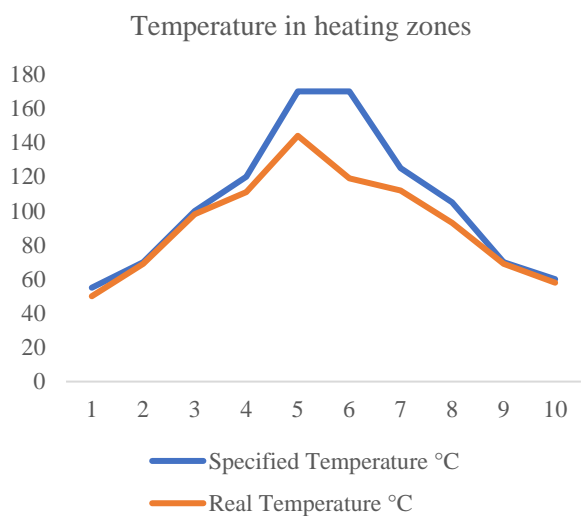
As can be seen in Table 1. The ambient temperature ranged from 16.5°C to 28.9°C. The ambient temperature on the Stringer machine ranged from 20°C to 42°C. As can be noticed this temperature variation is due to the environmental changes that naturally occur during all the months of the year, which influences the heating zones, as well as the variation of the temperature of the heads in the welding areas of the Stringer machine. The temperature variation in the welding areas at 9 a.m. ranged from -26.3°C to -51.6°C. Table 2, Graph 1.

**Graph 1** Temperature in heating zones at 9 o'clock  
*Own Elaboration*

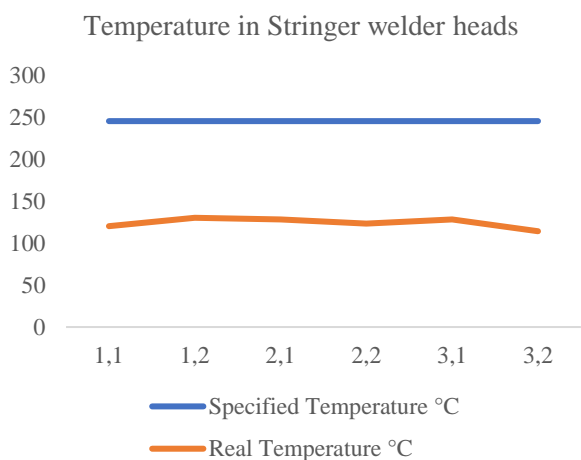
The temperature variation in the Stringer welder heads at 9 a.m. ranged from -114.9°C to -130.6°C of the specified value. Table 3. Figure 2.

**Graph 2** Temperature monitoring in Welder Heads at 9 a.m  
*Own Elaboration*

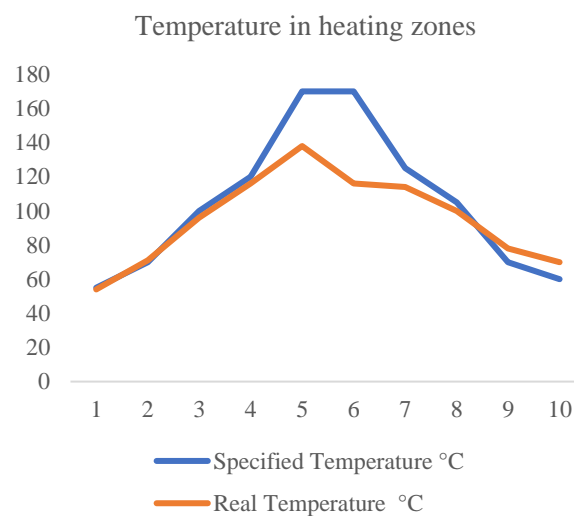
Temperature variation in the welding heating zones at 12 hours ranged from -32°C in zone 5 to -54°C in zone 6. With respect to the specified value. Table 4. Figure 3.

**Graph 3** Temperature in heating zones at 12 hours  
*Own Elaboration*

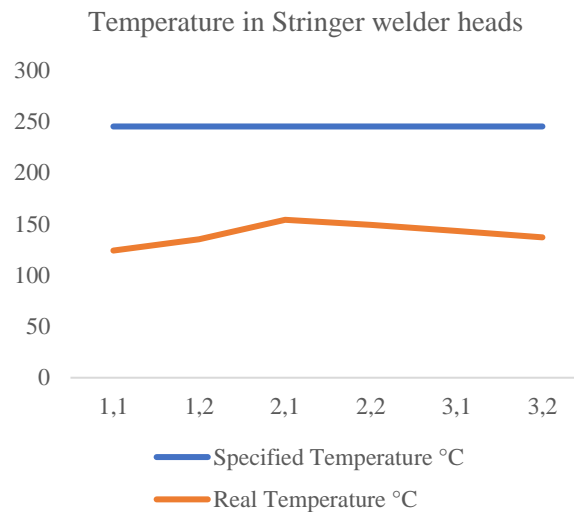
Temperature variation in stringer weld heads at 12 o'clock ranged from -91°C to -121°C of the specified value. Table 5. Figure 4.

**Graph 4** Temperature in Stringer Welder Heads. (12 hours)  
*Own Elaboration*

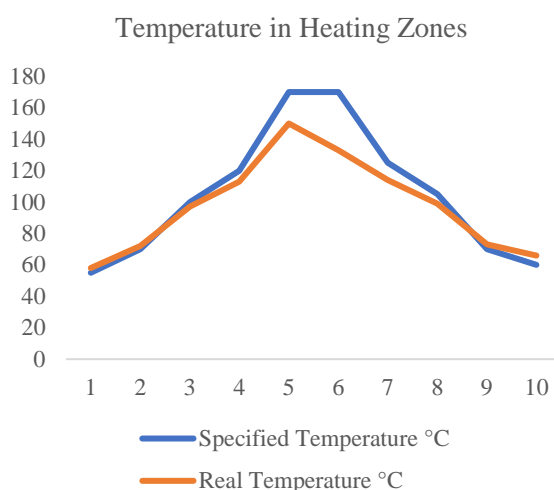
Temperature variation in the welding heating zones at 5 p.m. ranged from -20°C in zone 5 to -36°C in zone 6. With respect to the specified value. Table 6. Figure 5.

**Graph 5** Temperature in Heating Zones. Monitoring at 17 hours  
Own elaboration

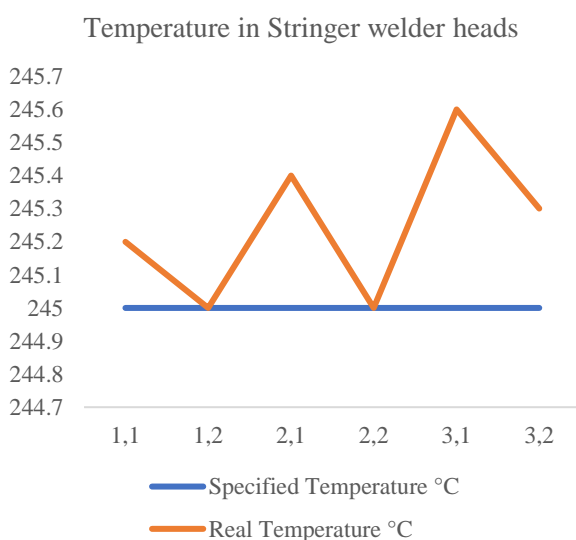
The temperature variation in the Stringer welder heads at 5 p.m. ranged from 0°C to +1.2°C of the specified value. Table 7. Figure 6.

**Graph 6** Temperature in Stringer Welder Heads. Data measured at 17 hours  
Own Elaboration

As you can see. In the morning when the ambient temperature is lower, the variation in the welding heads is greater. However, at 17 hours when the Stringer machine has worked 9 hours the temperature of the heads is within specification  $\pm 10^{\circ}\text{C}$ . This indicates that the machine should remain without shutting down 24 hours, it is also advisable to have controlled ambient temperature conditions in the welding area, to reduce temperature variations, as they influence lack of welding in solar cells.
