Importance of TSU participating in the industry 4.0 on the measurement systems of CFE**Importancia de la participación del TSU en la Industria 4.0 en Sistemas de Medición de CFE**

FLORES-LICÓN, María del Rocío†*, VALLES-CHÁVEZ, Adolfo and CASTILLO-PÉREZ, Martha Lina

Universidad Tecnológica de Chihuahua, Avenue Montes Americanos 9501 secc. 35, Chihuahua Chih.C.P. 31216

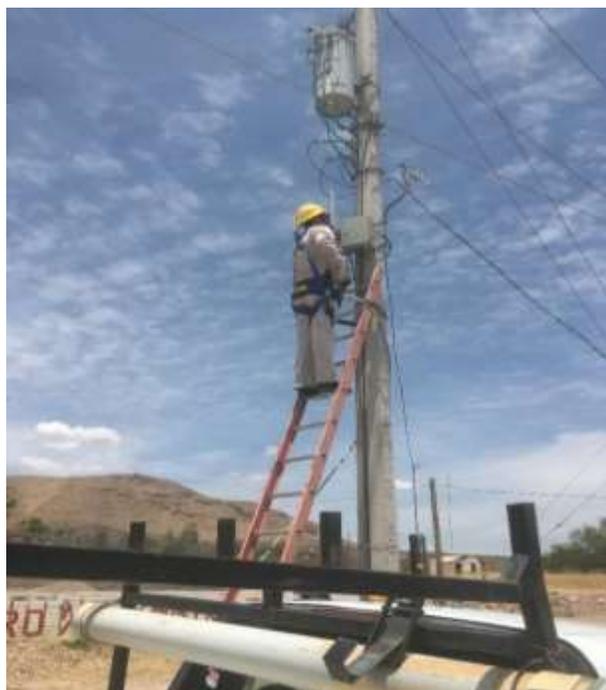
Figure 3 Meter diagnosis

A diagnosis is performed in the area where the meter without communication was located, and then the equipment was checked to define the problem. Some of the problems may be: that the meter is burned, poor contact in the heavy-duty cable of the transformer that energizes the source, broken or disoriented antenna and sometimes obstructed by agricultural walnuts, the configuration of the radio in one of the partitions is incorrect, or that the source is burned or the direct current voltage output is damaged.
